Manhole Inspection Summary

Manhole # S41C__022MH

Location Address: **1403 e fayette st**

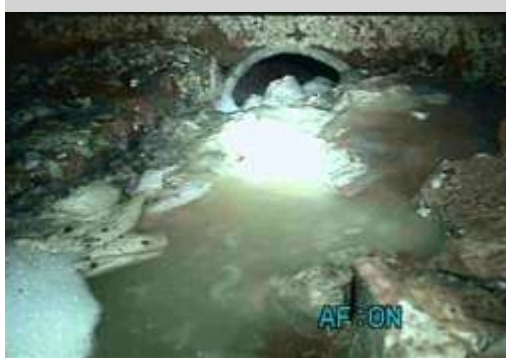
Defect 3

Condition: ☐ Sound ☐ Cracked ☐ Root Intrusion ☐ Deteriorated ☐ Leaks ☒ **Debris**

channel debris

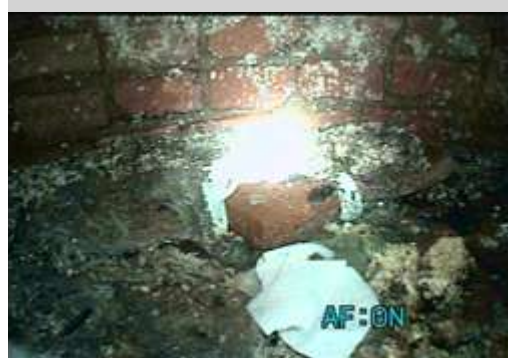
Defect 2

Condition: ☐ Sound ☐ Cracked ☐ Root Intrusion ☐ Deteriorated ☐ Leaks ☒ **Debris**

bench debris

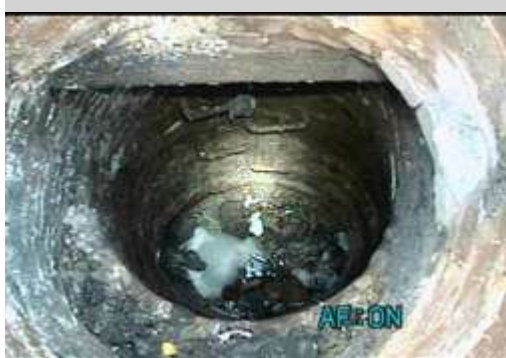
Defect 1

Count: **6** Missing: **0** ☒ **Corroded**

cor. steps

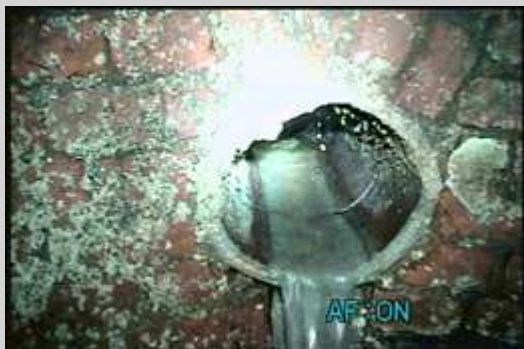
6 O'Clock Inflow

no drop. no pipe under it
